## **Appendix C: Worst Performing Circuit Inspections**

### **Worst Performing Circuit Inspections:**

### **Staff Observations – Monday June 13, 2005**

ComEd Chicago Region

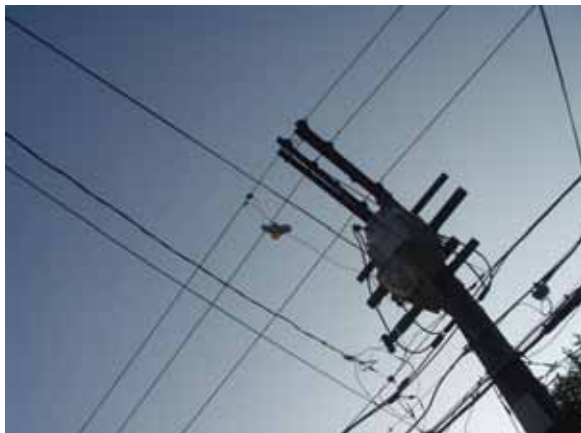
P6130008 – shoes on center phase hanging down to xfmr tap and very close to touching tap

ComEd personnel present with Staff called in to have shoes removed.

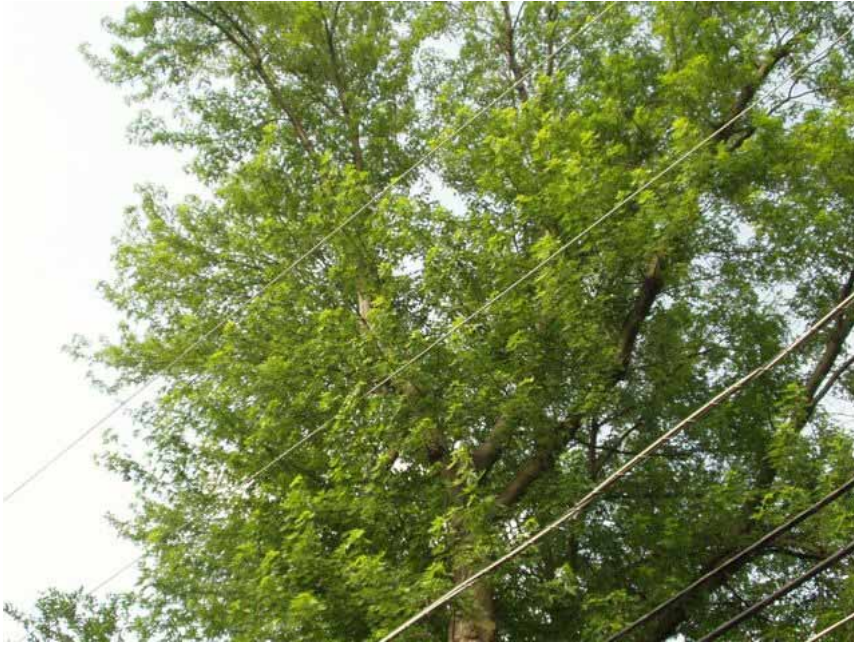
P6130013 – field phase of primary into tree.

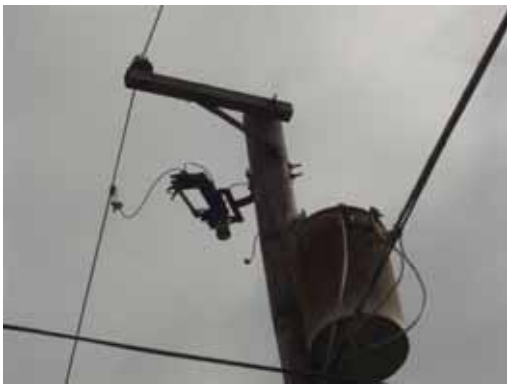
P6140038 – Blown Lightning Arrestor

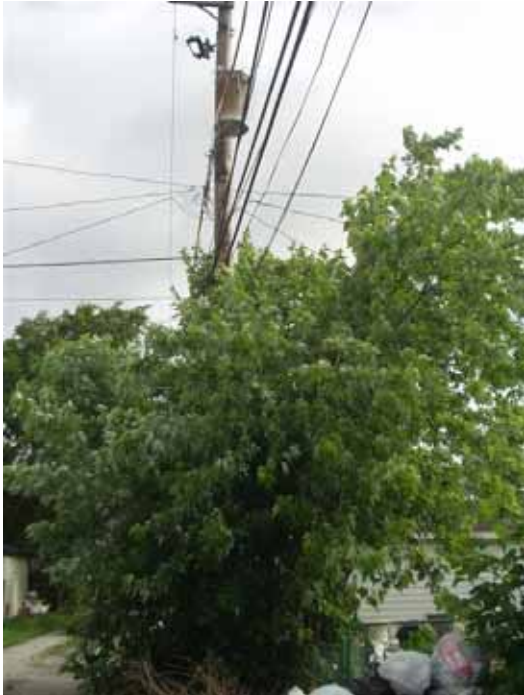
P6140039 – Silver Maple directly below transformer & primary and will be source of future problems/expense

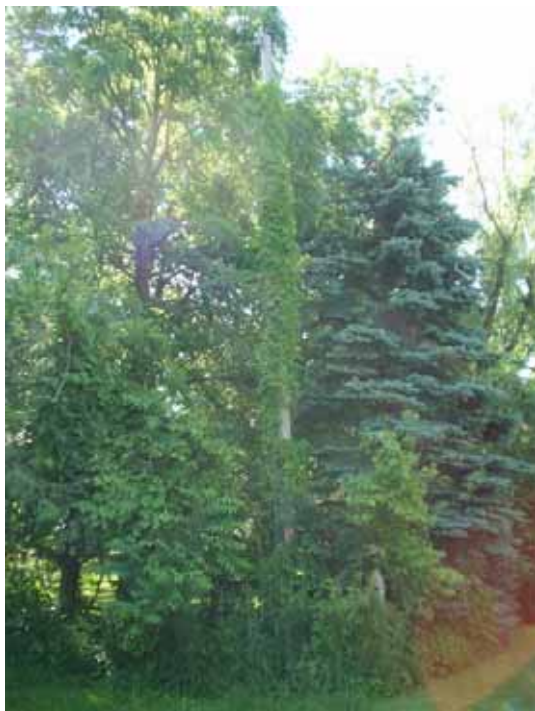
P62000012 -- vines growing on a pole

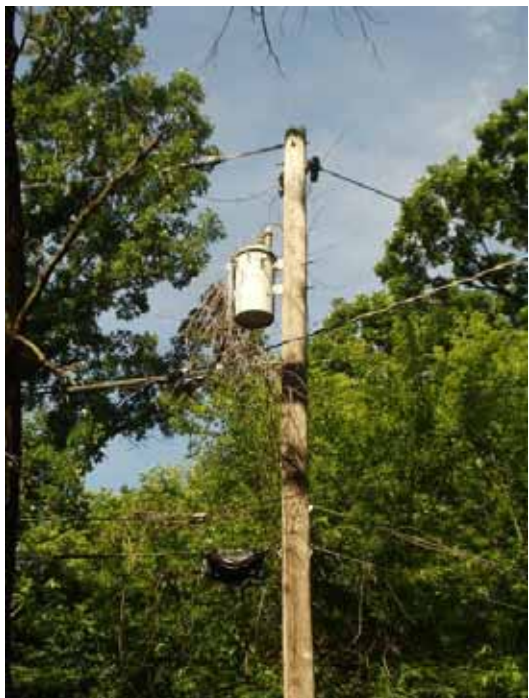
P62000014 – dead vines on a pole – sign of previous problems in the area.

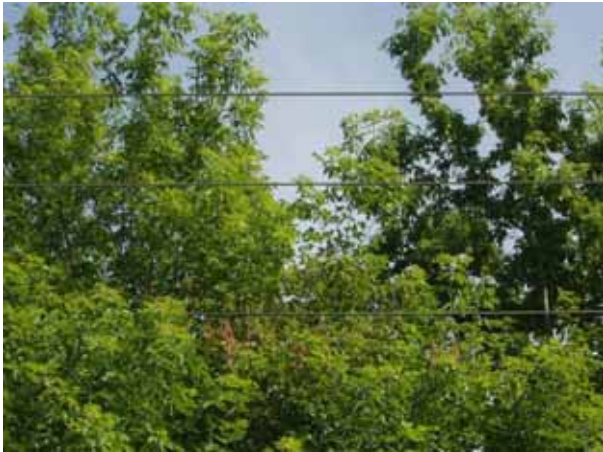
P6210027 – “Electro-trimming” seen in trees. Trees into primary.

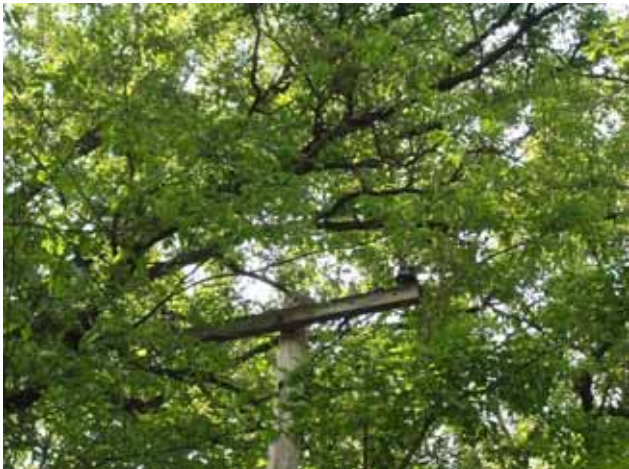
P6210028 – field side phase of tap is energized and is fused on this customer owned line. The entire length of this customer circuit is heavily into the trees and vines for about 1,000 feet. ComEd comments that the customer is responsible for trimming the customer owned tap. In Staff's opinion the most important thing to note about this tap is that it is fused.

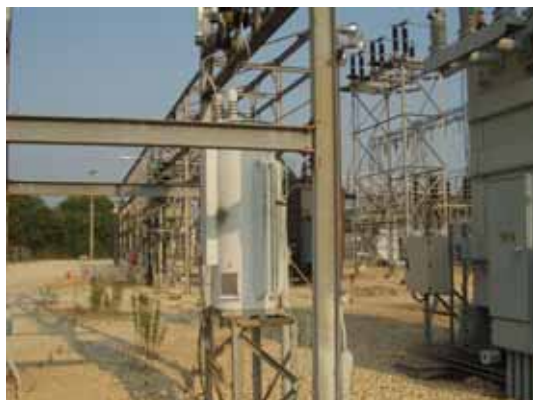
P6270003 – weeds in yard

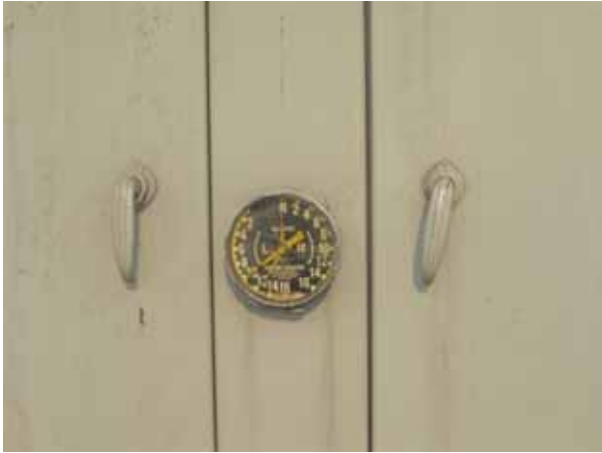
P6270004 – TR 76 Xfmr Tap at 10L w/range from nR to 12L. TR 77, 78, 79, 73 were similar.

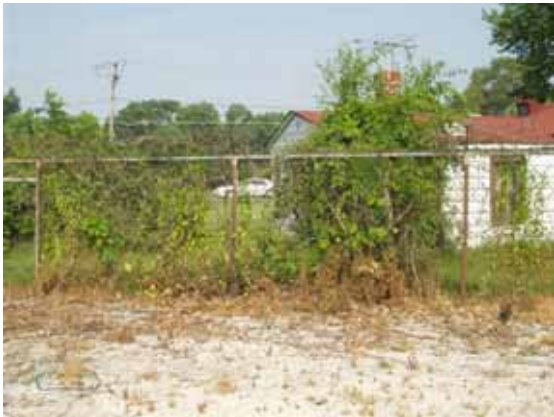
P6270025 – Vegetation within Substation. There was some trash in this area but ComEd personnel with Staff picked it up as they came into the Substation.

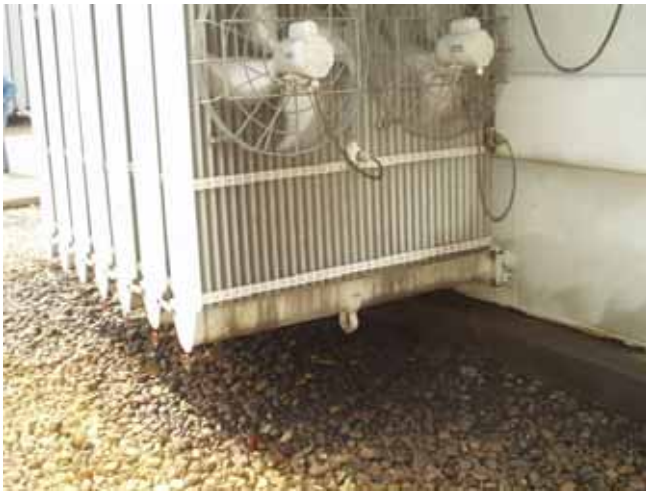
P6270032 – Oil on ground below cooling fins of XFMR71

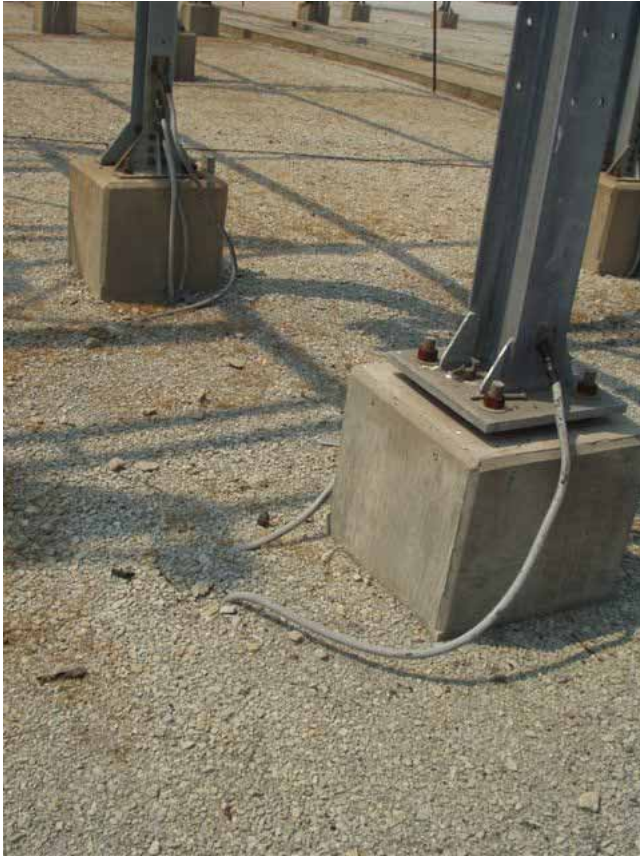
P6270048 – Ground wires laying on/across top of ground

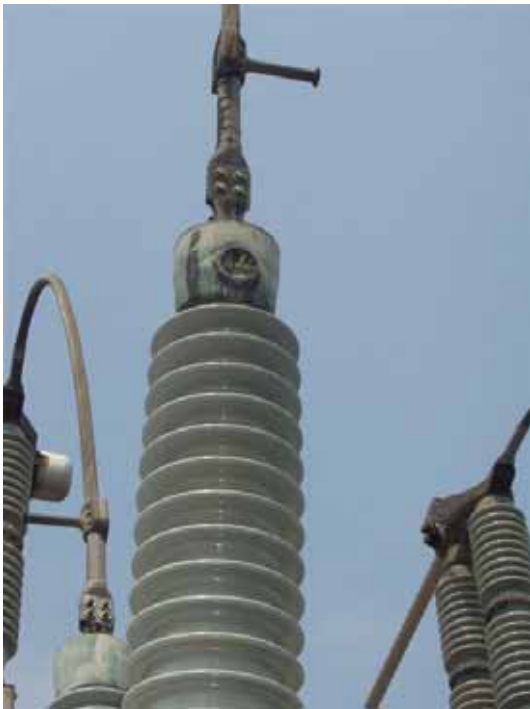
P6270049 – C phase bushing of Oil Circuit Breaker (“OCB”) L0708 oil level is high

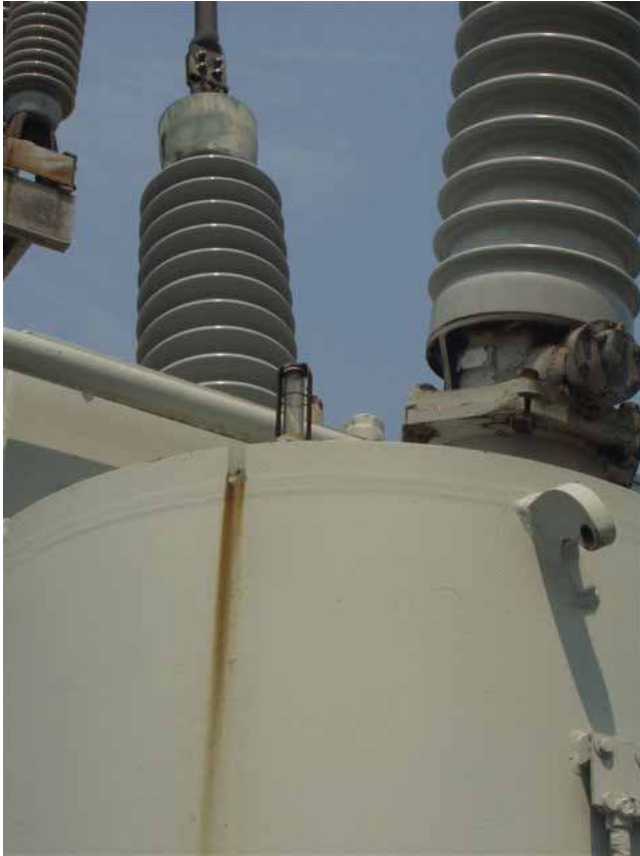
P6270050 – A phase oil level in tank OCB L0707 plug/float up against top of tank oil gauge

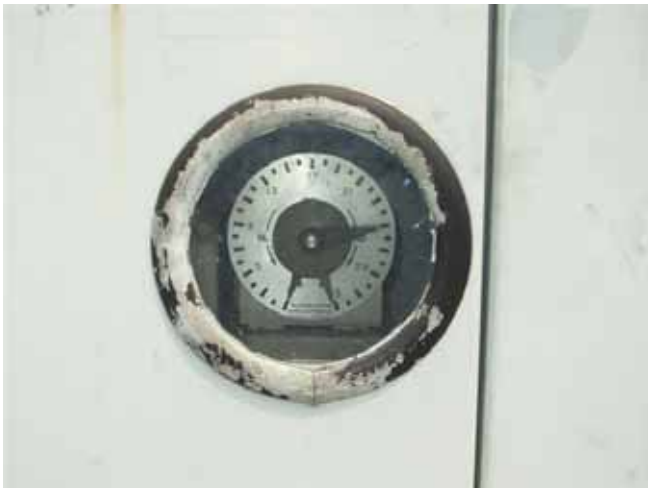
P6270067 – XFMR72Y LTC shows that it has operated in both extreme positions

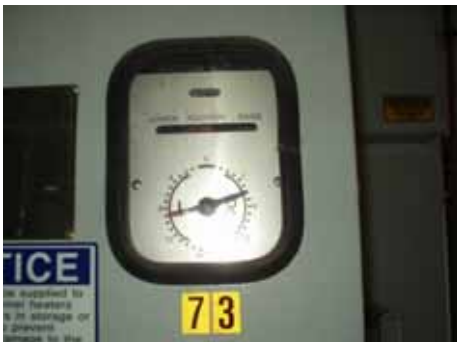
P6270078 – XFMR73 LTC -- Xfmr72 LTC & XFMR71 LTC looked similar

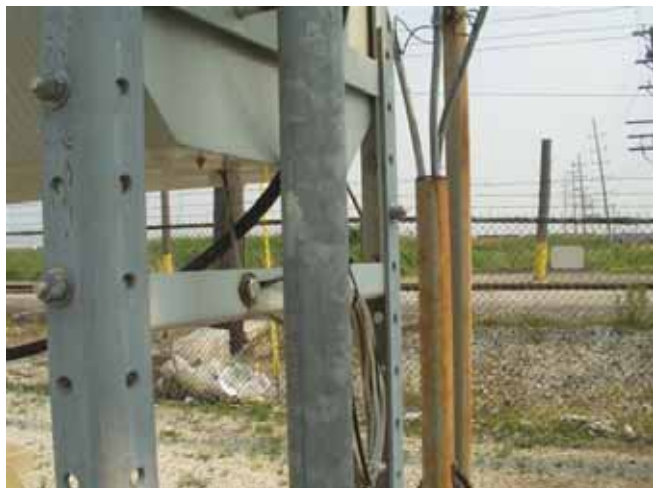
P6270098 – Ground wire coiled up outside to go inside D5004 switchgear

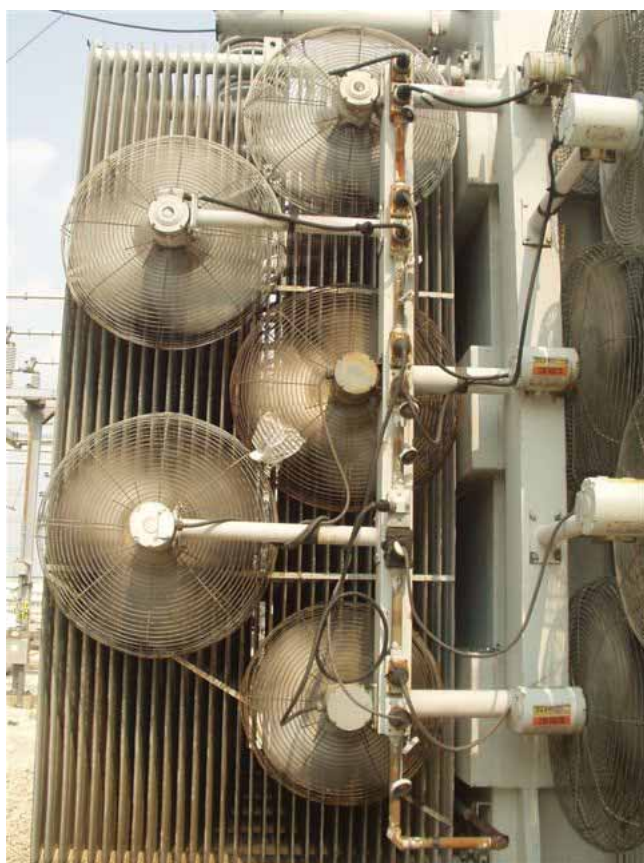
P6270099 – Trash on XFMR cooling fan.

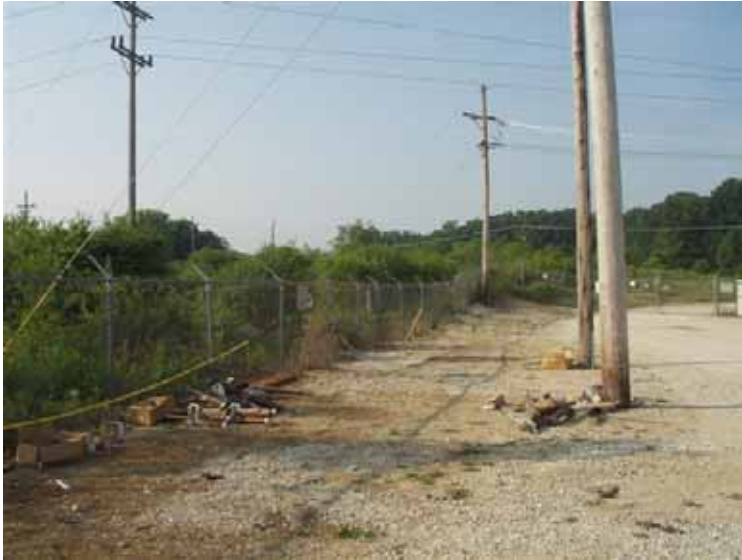
P6280103 – Equipment & debris in yard and along fence – as well as equipment stored for later use.

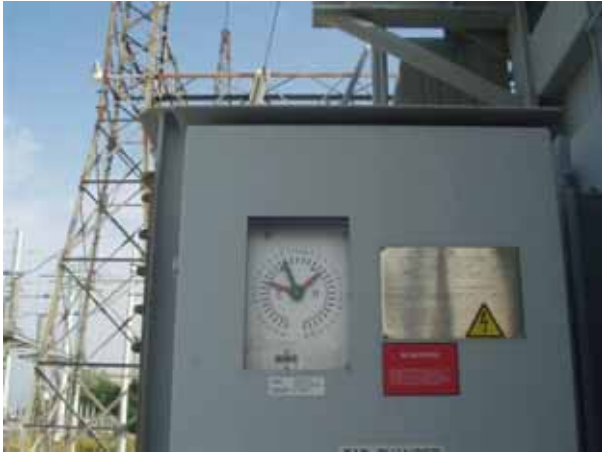
P6280106 – XFMR77 LTC – looks like operation is symmetrical about neutral.

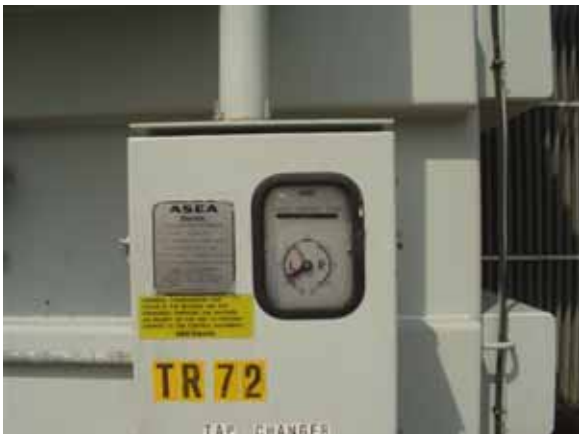
P6280123 – XFMR72 LTC – Bushing oil on XFMR looked high and noted some oil around base

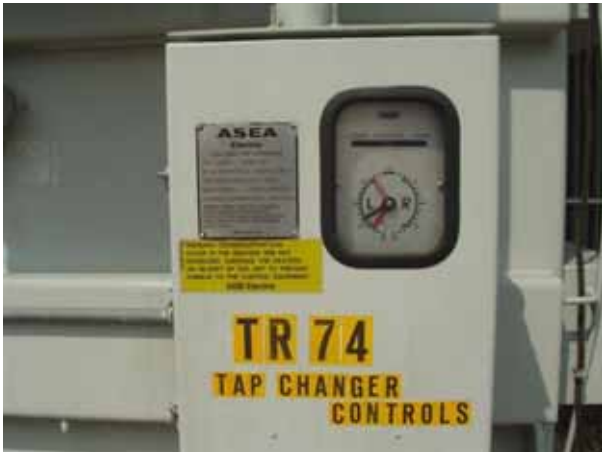
P6280125 – XFM74 LTC – noted that XFM74 had new radiators

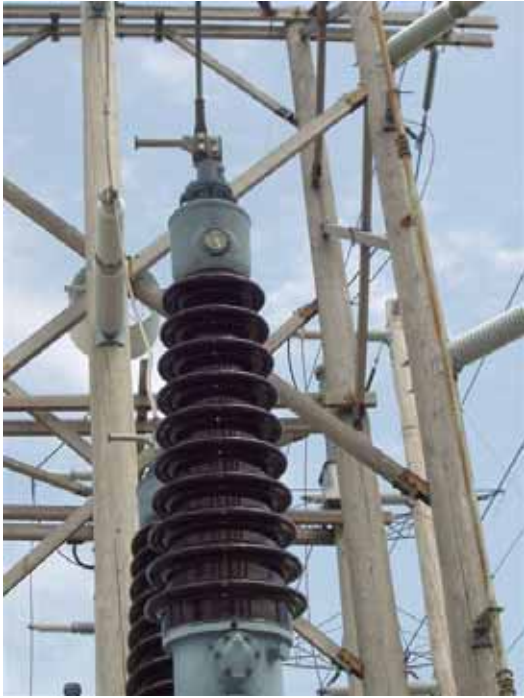
P6280140 – L14310 OCG 138KV BREAKER – B phase bushing oil low – ComEd personnel know about it and are waiting for the next planned outage to correct

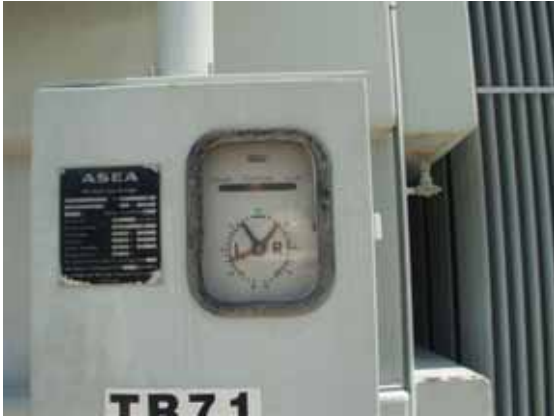
P6280145 – XFMR71 LTC

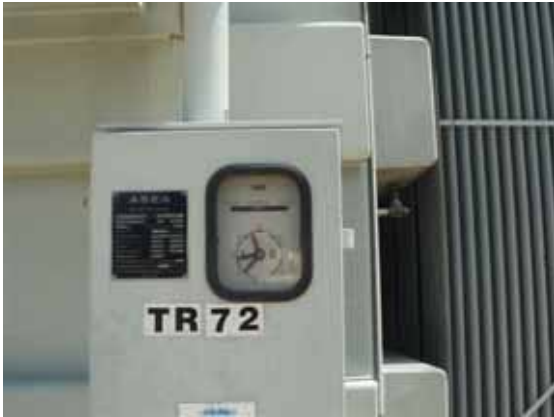
P6280146 – XFMR72 LTC

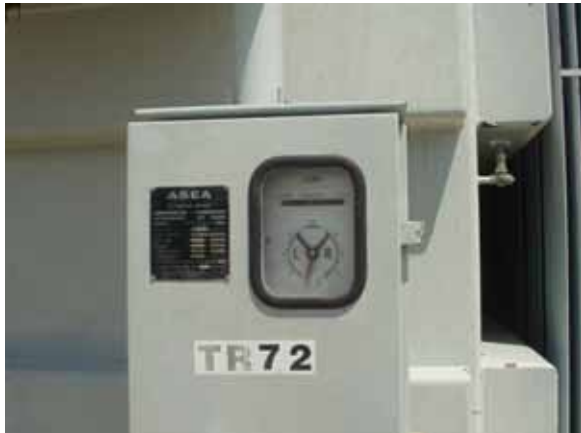
P6280156 – XFMR72 LTC – also noted that C phase bushing oil level was high

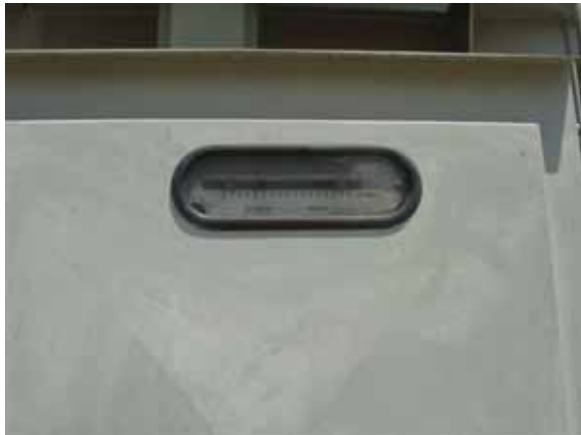
P6280157 – XFMR71 LTC

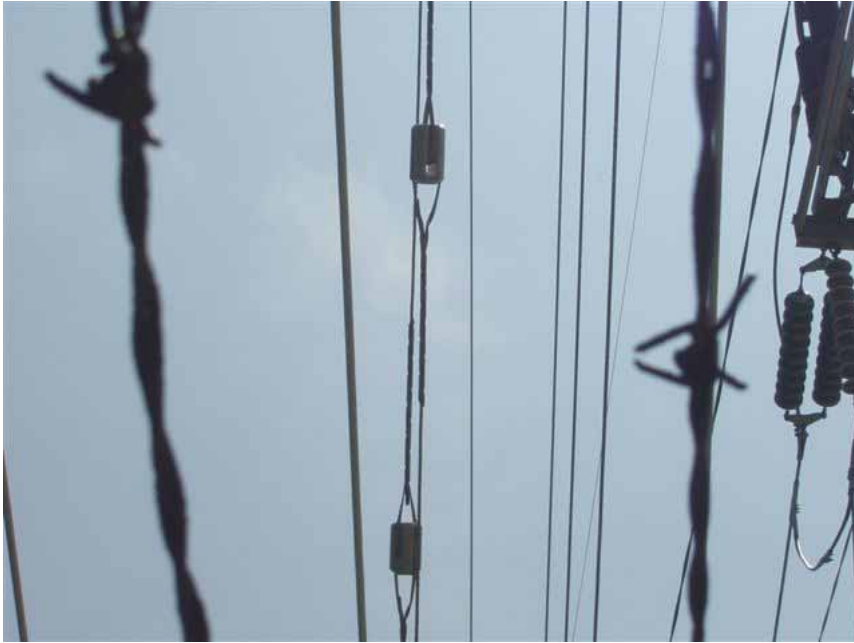
P6280163 – guy wire that looks close to primary

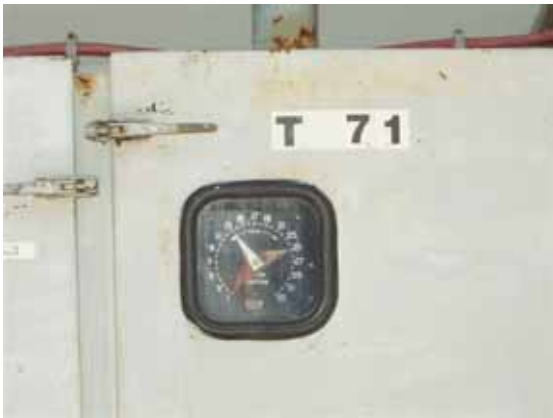
P6280170 – XFMR71 LTC – some rust on equipment – some oil leakage at this XFMR

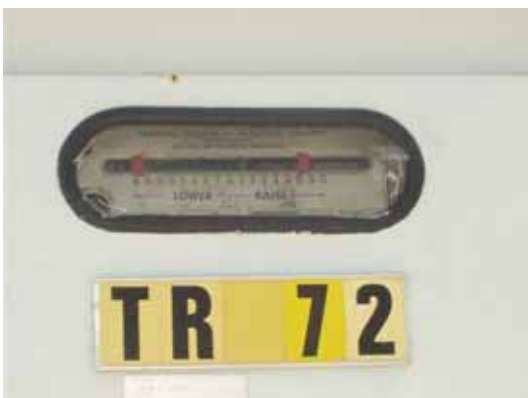
P6280172 – XFMR72 LTC – stop at 16 lower

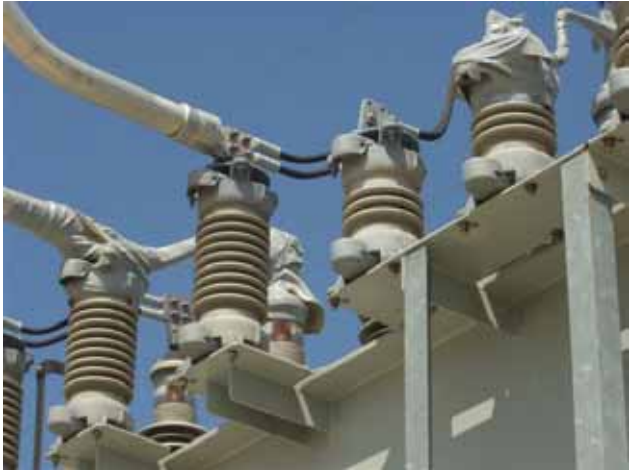
P6280173 – XFMR77 lose tape on insulator

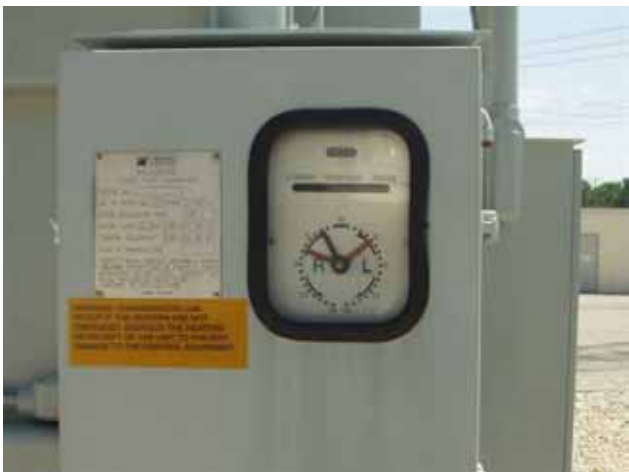
P6280175 – XFMR77 LTC

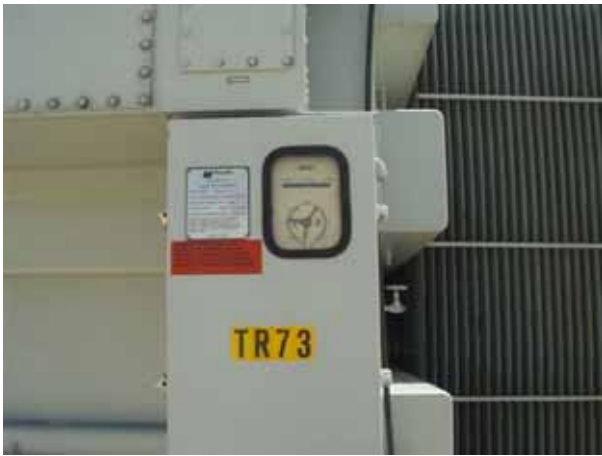
P6280176 – XFMR73 LTC – stop at 16 lower

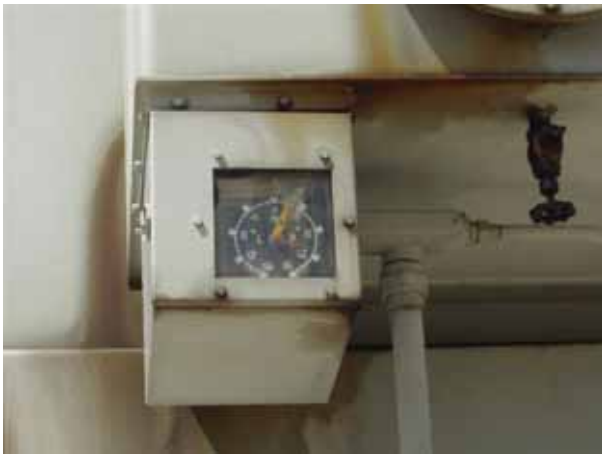
P6280177 – XFMR74 LTC

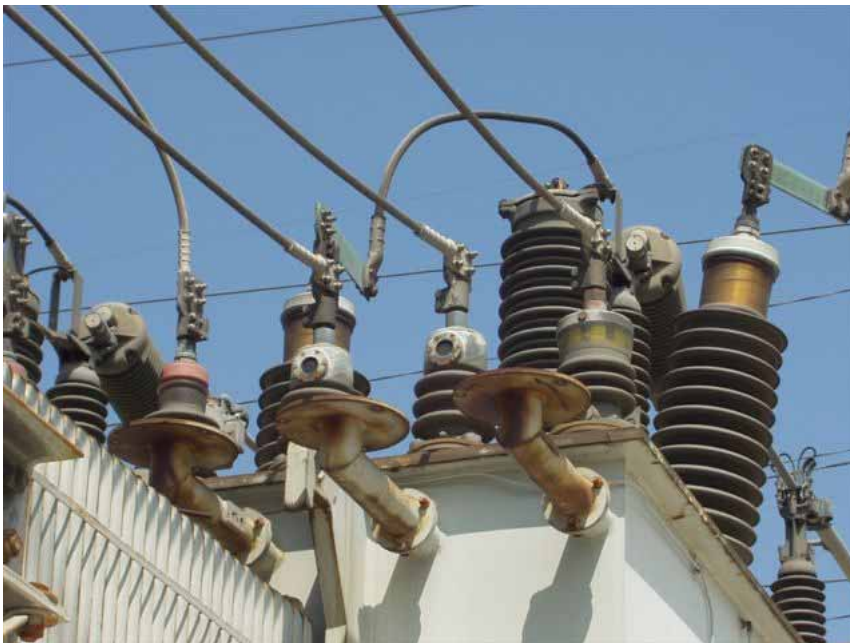
P6280178 – XFMR78 2 phases on low side can't read oil level from ground without binoculars

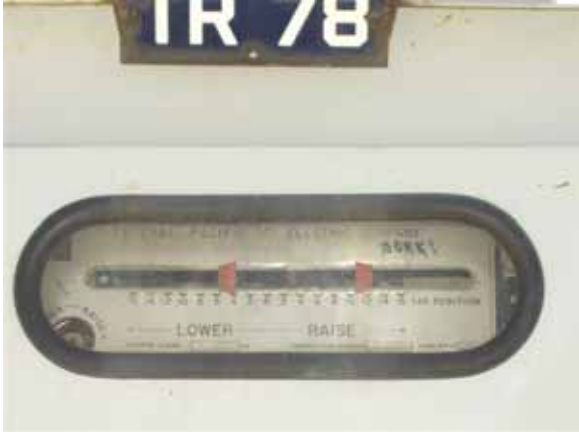
P6280179 – XFMR78 LTC -- XFMR 79 LTC similar
